# 실험실과 Pilot설비 사고 사례와 안전

2013. 7. 8.

윤 용 승  
고등기술연구원  
플랜트엔지니어링 본부

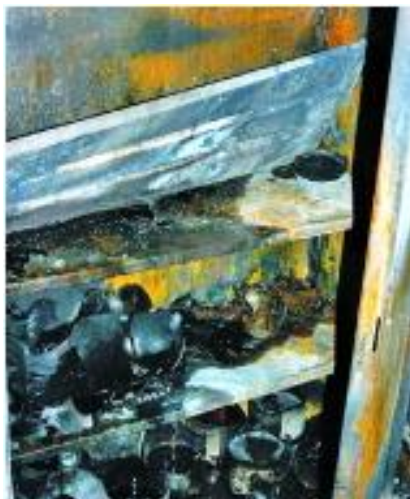
무너진 캐비닛 선반

- 2005년 4월 8일(금) 저녁 발생
- 반입된 Hexane을 Solvent 저장 캐비닛에 옮기던 중 발생
- 캐비닛 위 선반에 12번째 솔벤트 병 넣을 때 캐비닛 선반이 무너져 hexane 다량 누출 → 5분 후 폭발 발생
- 화재 후 솔벤트 병들이 폭발
- 20만-30만불 재산 피해

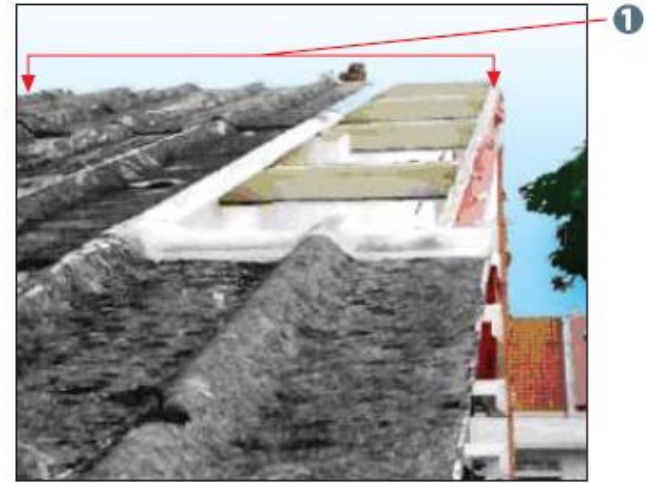
1. Roof tiles removed

A worker was installing lifelines on a pitched roof at a worksite. He stepped on one of the roof tiles which then broke under his weight. The worker suffered severe head and chest injuries and eventually succumbed to the injuries.

- When the worker went up the roof to install the lifelines, he had stepped onto the midsection of the roof tiles where there was no support structure. The roof tile hence broke under his weight.
- He fell from a height of 4.8m through the roof.

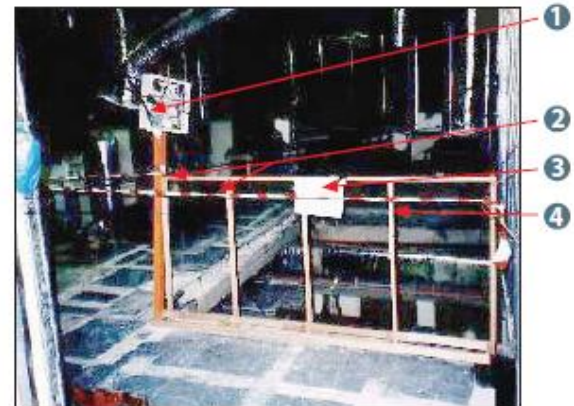
1. The electrical distribution box at the corner of the floor slab opening
2. The red-white tape and nylon rope used to barricade the two sides of the floor slab opening
3. The "Danger No Entry" signage
4. The wooden barricade (guarding only one side of the opening and not the remaining three)

- The 33rd level floor slab opening measured approximately 4m in length and 2.7m in width. The depth from the 33rd level to the 32nd level measured approximately 4m.
- The floor slab opening was meant for the staircase before it was dismantled. It was not guarded by any effective barrier to prevent falls.

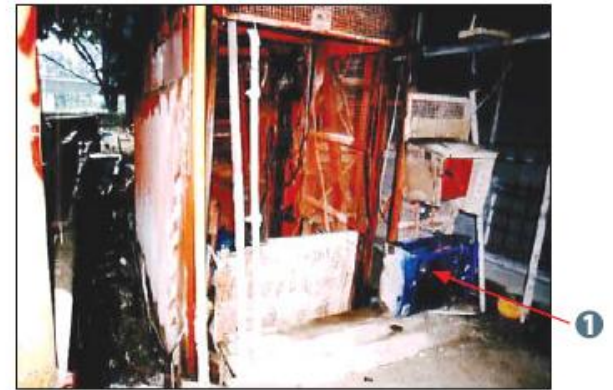
1. The control unit

- The PM hoist involved in the accident had been retrofitted by the hoist supplier with a machinery plate with a motor drive unit and a safety device.
- The most probable cause of the accident is the failure of the mounting bolts of the machinery plate. The fracture of these bolts caused the machinery plate to detach from the hoist cage.
- The hoist cage slammed onto the top of the drive unit, and knocked off the machinery plate with the drive unit from the rack, resulting in the free-falling of the hoist.

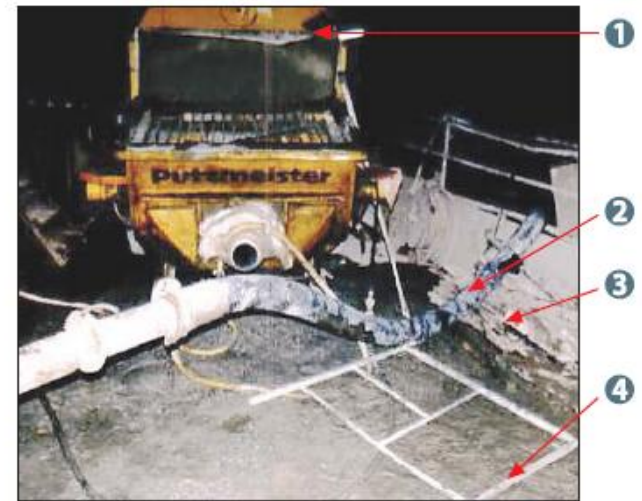
1. Concrete pump
2. Rubber hose
3. Timbers on the platform
4. Scaffold frame

The cleaning work was carried out by means of inserting a sponge ball into one end of the pipeline and feeding the pipeline with compressed air. The other end of the pipeline was equipped with a rubber hose to discharge the leftover concrete into a container. The workers were gripping the rubber hose while the pump operator held down the rubber hose with a steel tube.

When the sponge ball was forced out from the rubber hose, the hose swung suddenly and hit the pump operator. He was flung off the platform and landed on the bottom of the shaft. He died on the spot.

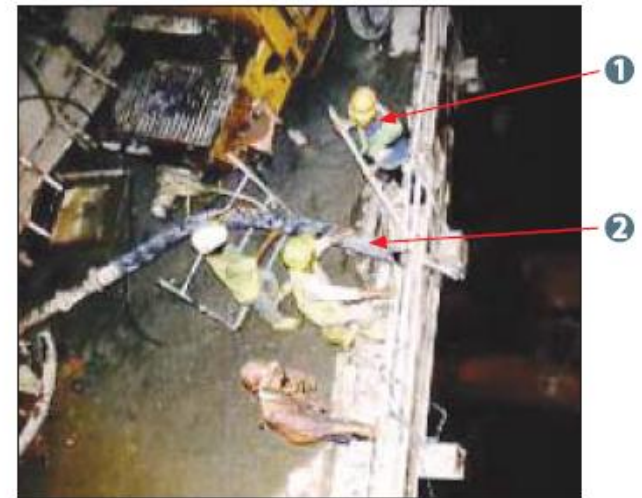
1. Deceased was standing here prior to the accident
2. Rubber hose was placed on a scaffold frame

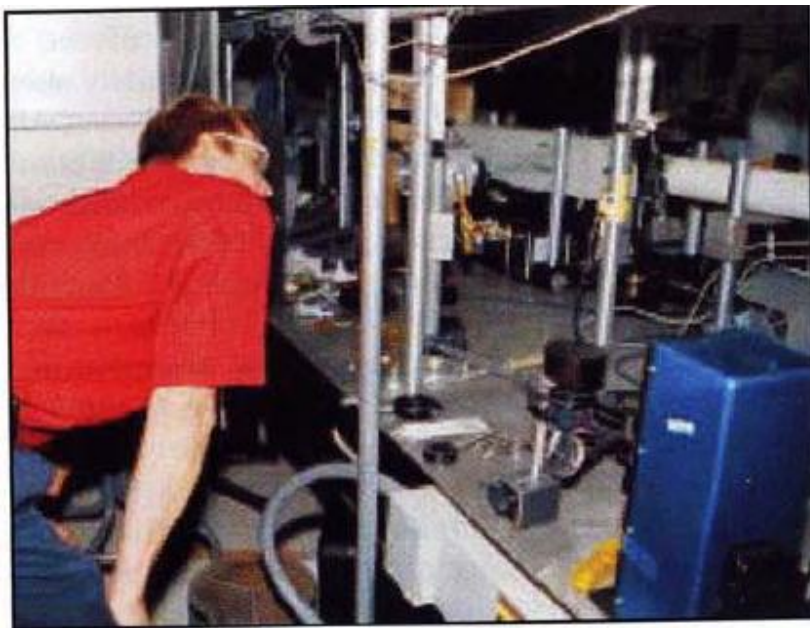
A student suffered permanent vision loss by looking directly into the target chamber of a laser experiment without safety eyewear (recreated here). The injury resulted in a multiweek shutdown of all scientific work at the lab. Be conscientious that violating laser safety protocols poses not only a risk to the individual, but also a severe imposition to one's colleagues.

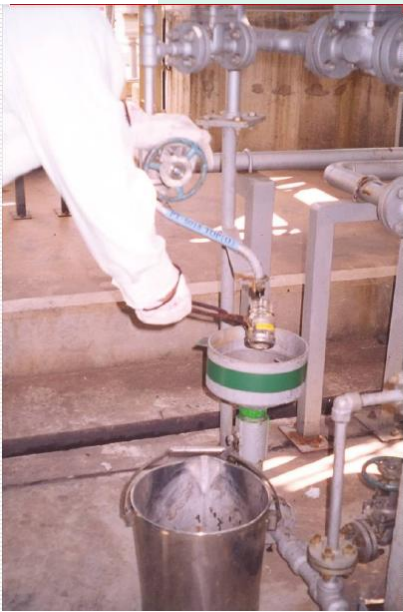
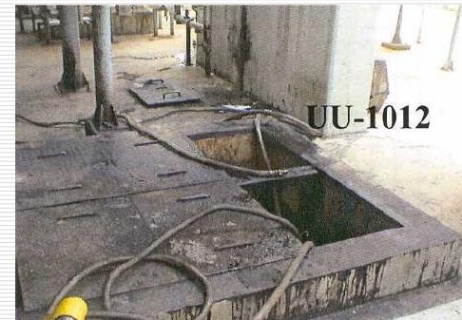
Date	July 2004
Work Process	Non-routine sample collection
Casualty	Chemical burns

- Worker collected samples from specific process lines with flushing fluid collected in a bucket.
- The bucket of flushing fluid was to be disposed into a specific pit.

- While opening the pit cover, worker lost his balance and knocked over the bucket of flushing fluid.
- The flushing fluid spilt onto his body.

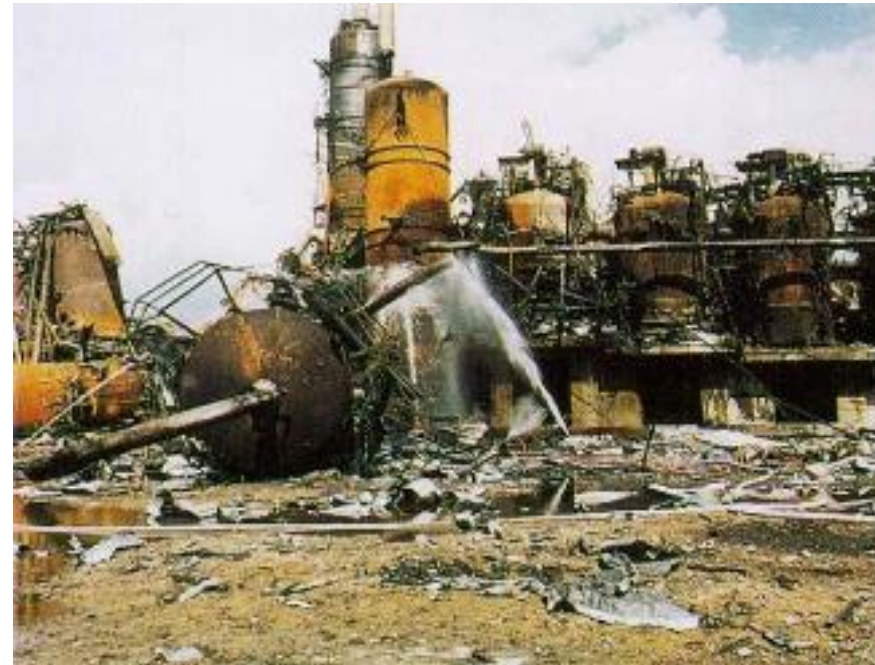
- 반응기 5 본체에 crack 발생, 수리 위해 제거
- 반응기 4,6번 flexible hose 연결 계속 운전 결정
- 28" 파이프 직경이나, 20" 파이프만 있어 사용
- By-pass 라인 터져 30톤 cyclohexane 누출, 45초 후 폭발

- 1974년 6월 토요일 발생
- 28명 사망(제어실 천장 무너져 제어실 18명 전원 사망), 36명 부상
- 나일론 원료인 카프로락탐 7만톤/년 생산 공장
- 휘발유와 성상이 비슷한 cyclohexane 사용하는 공정 (7.7 atm, 155°C)
- Cyclohexane은 상압이 되면 곧 휘발하는 특성

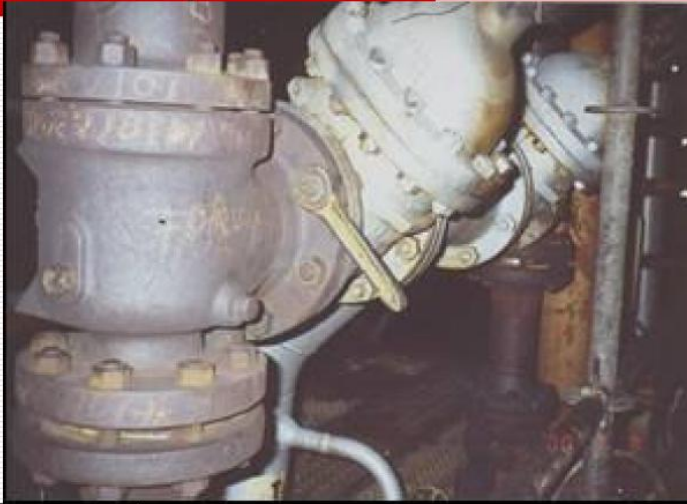
Date	July 2000
Work Process	Removal of relief valve on plant unit
Casualty	One death and one injured

Scene of accident  
showing the scaffold  
staging near the  
wrong valve

- ❑ Workers did not know the label on RV which they were supposed to remove, and instead dismantled the wrong one without checking the label.

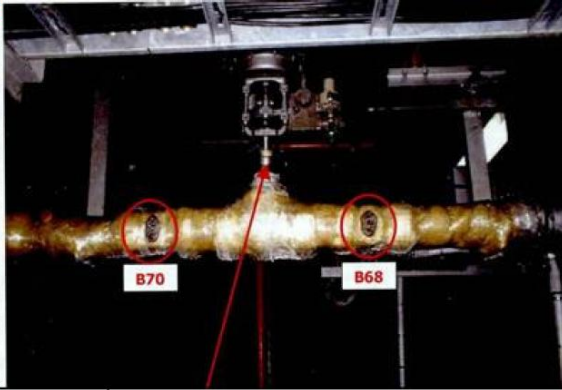
Date	May 2003
Work Process	Testing for presence of toxic gas at pipeline
Casualty	One injured

- Some phosgene vapours escaped from the manual valve as he slowly opened it, thus inhaling some in the process.

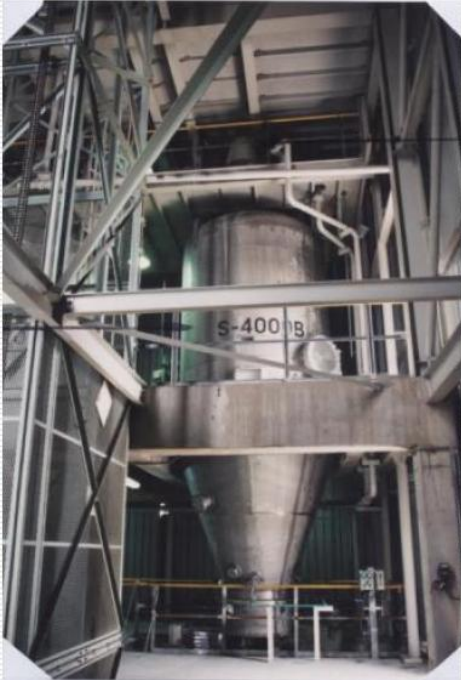
<b>Date</b>	<b>March 2005</b>
<b>Work Process</b>	<b>Discharging of chemicals from tote bin into a hopper</b>
<b>Casualty</b>	<b>One death and One injured</b>

- ❑ 2 workers were carrying out the discharging of  $P_2S_5$  from a tote bin into a hopper.
- ❑ 5 minutes into the process, an explosion followed by a fire occurred at the discharging area.
- ❑ 1 worker managed to escape and suffered 20% burns at the back of his body.
- ❑ Inert atmosphere required in the hopper not maintained.
- ❑ Workers had not checked if the valve supplying nitrogen gas to the hopper was open.
- ❑ It was not work procedure to conduct the check.

The explosive force caused the tote bin involved to topple and land on the deceased

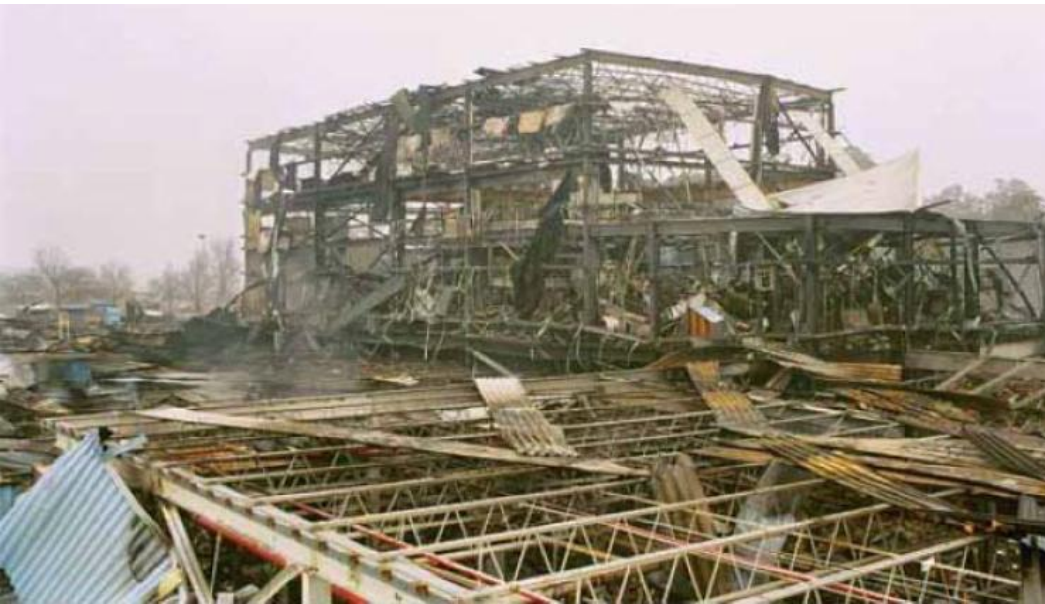
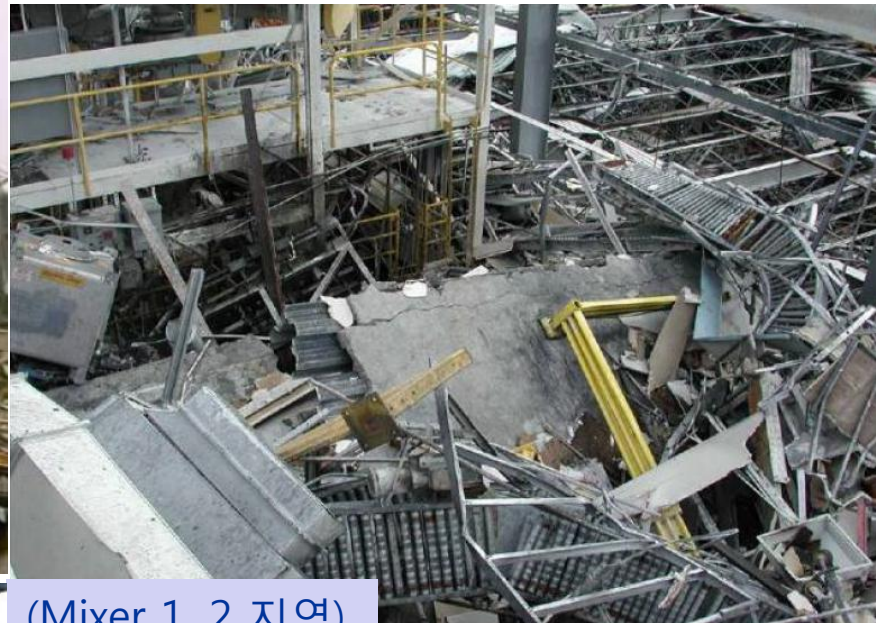
(Mixer 1, 2 지역)

2003/01/29. 미국 West Pharmaceutical Services, Ltd., 분진폭발 6명 사망

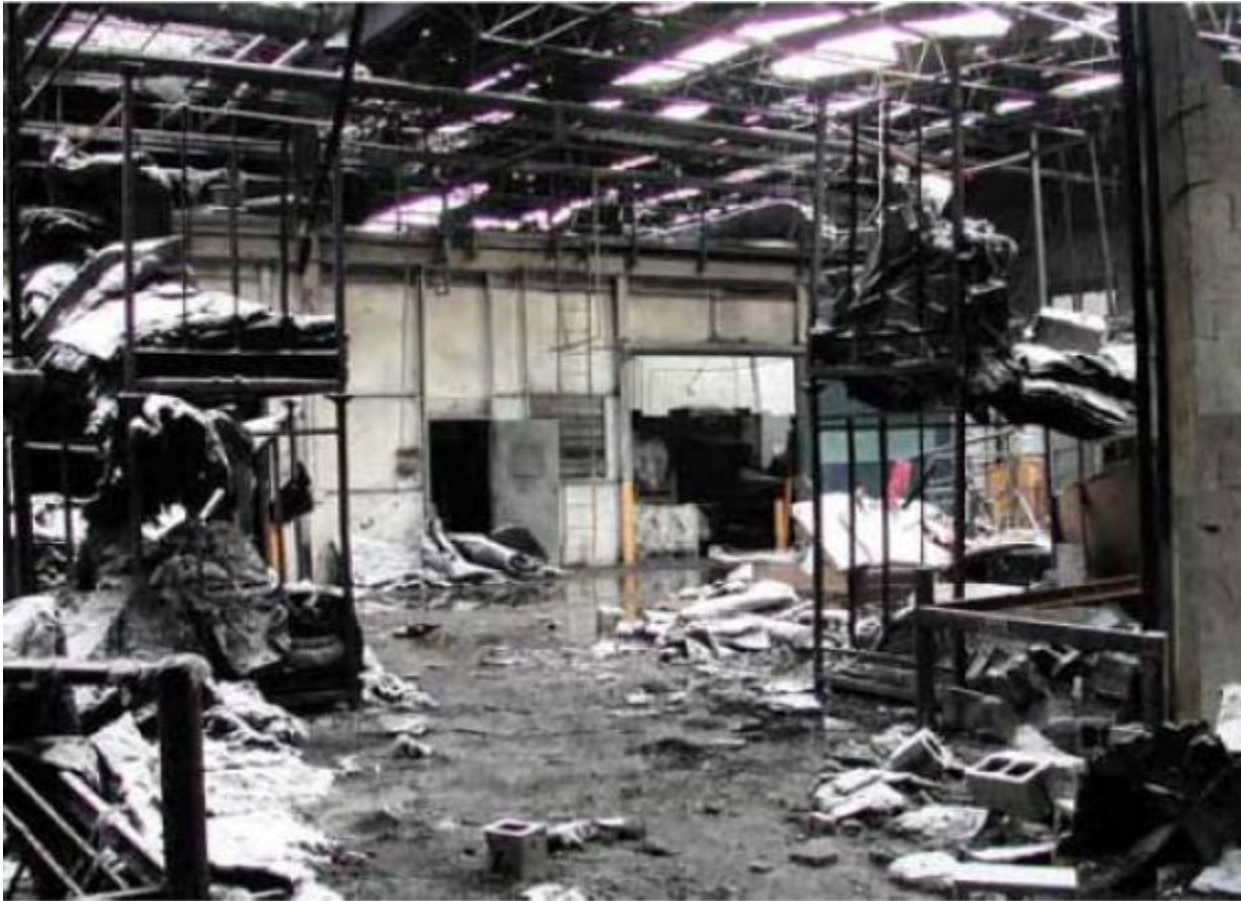
2003/02/20. 미국 CTA Acoustics사, 분진폭발 7명 사망, 37명 부상

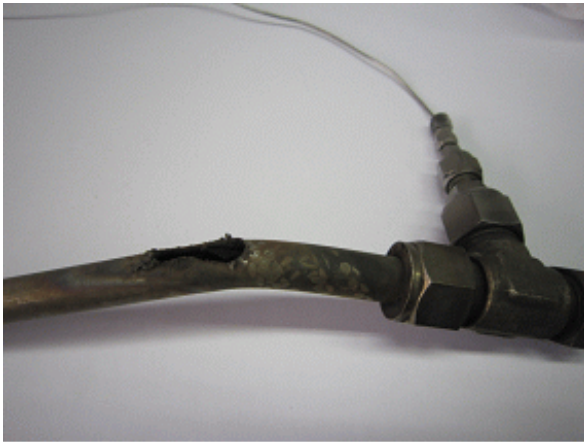
Damaged SUS coal powder feeding pipe occurred at the 8 bar and around 1,500°C gasification pilot plant test.

**합성가스 폭발 파괴력은 1,500 psi 밸브 SUS 금속 찢을 정도**

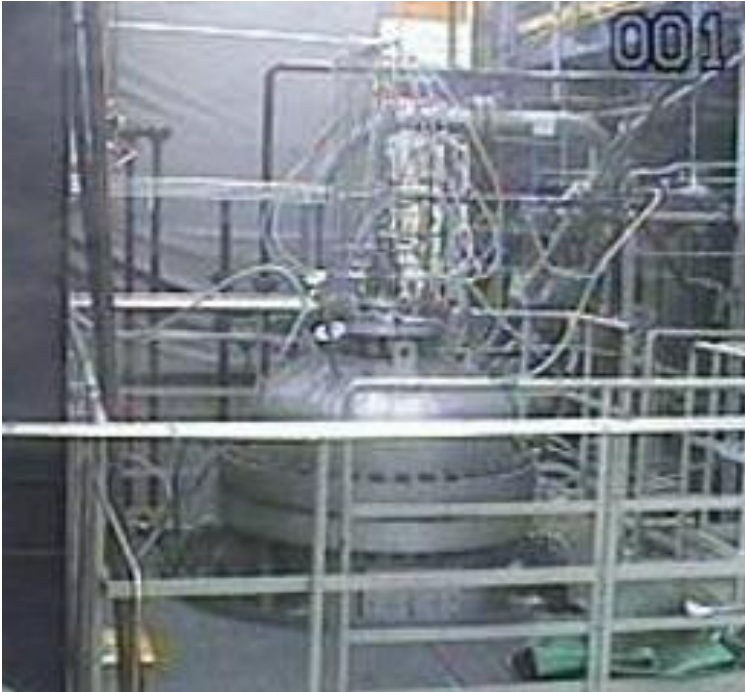
석탄가스화기 상부 (정상 운전)

# Explosion accident at the coal feeding nozzle during the pilot gasifier operation at 20 bar, 1,400°C

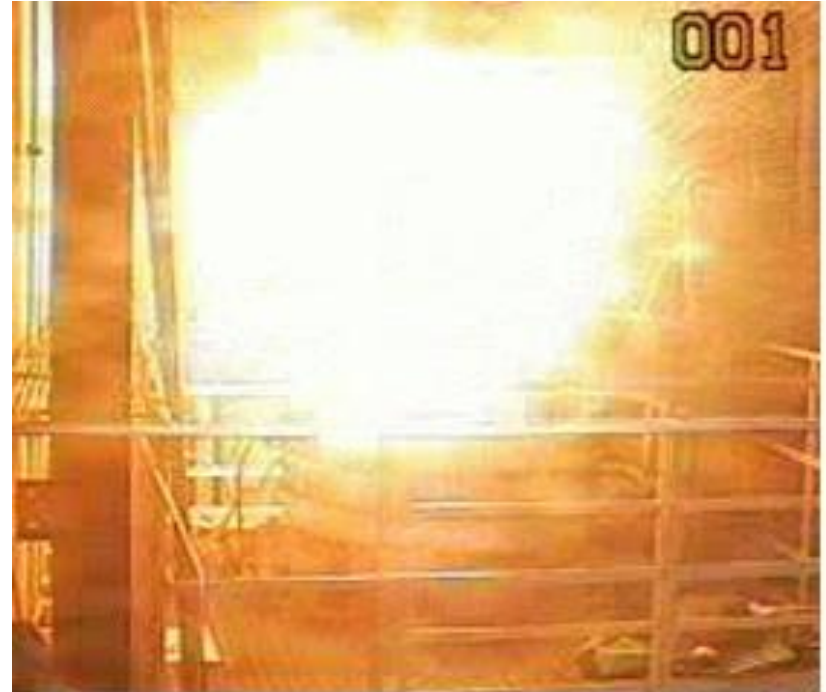
석탄가스화기 상부 (노즐 폭발)

폭발 시간은 수초, 미세 금속조각 파편에 노출 위험
