Progress in Japanese Air-blown IGCC Demonstration Project Update

Clean Coal Power R&D Co., Ltd.

Located within the NAKOSO Power Station
of JOBAN JOINT POWER CO.,LTD.

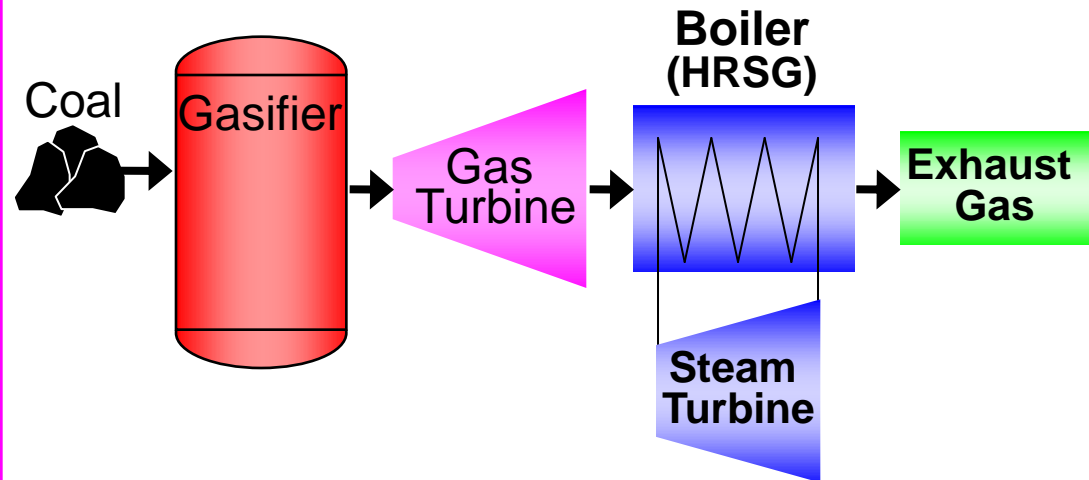
Boiler + Steam Turbine

+ Gasifier + Gas Turbine

IGCC is a new power generation system aiming at higher efficiency than conventional coal-fired systems by integrated coal gasification with combined cycle power generation technology.

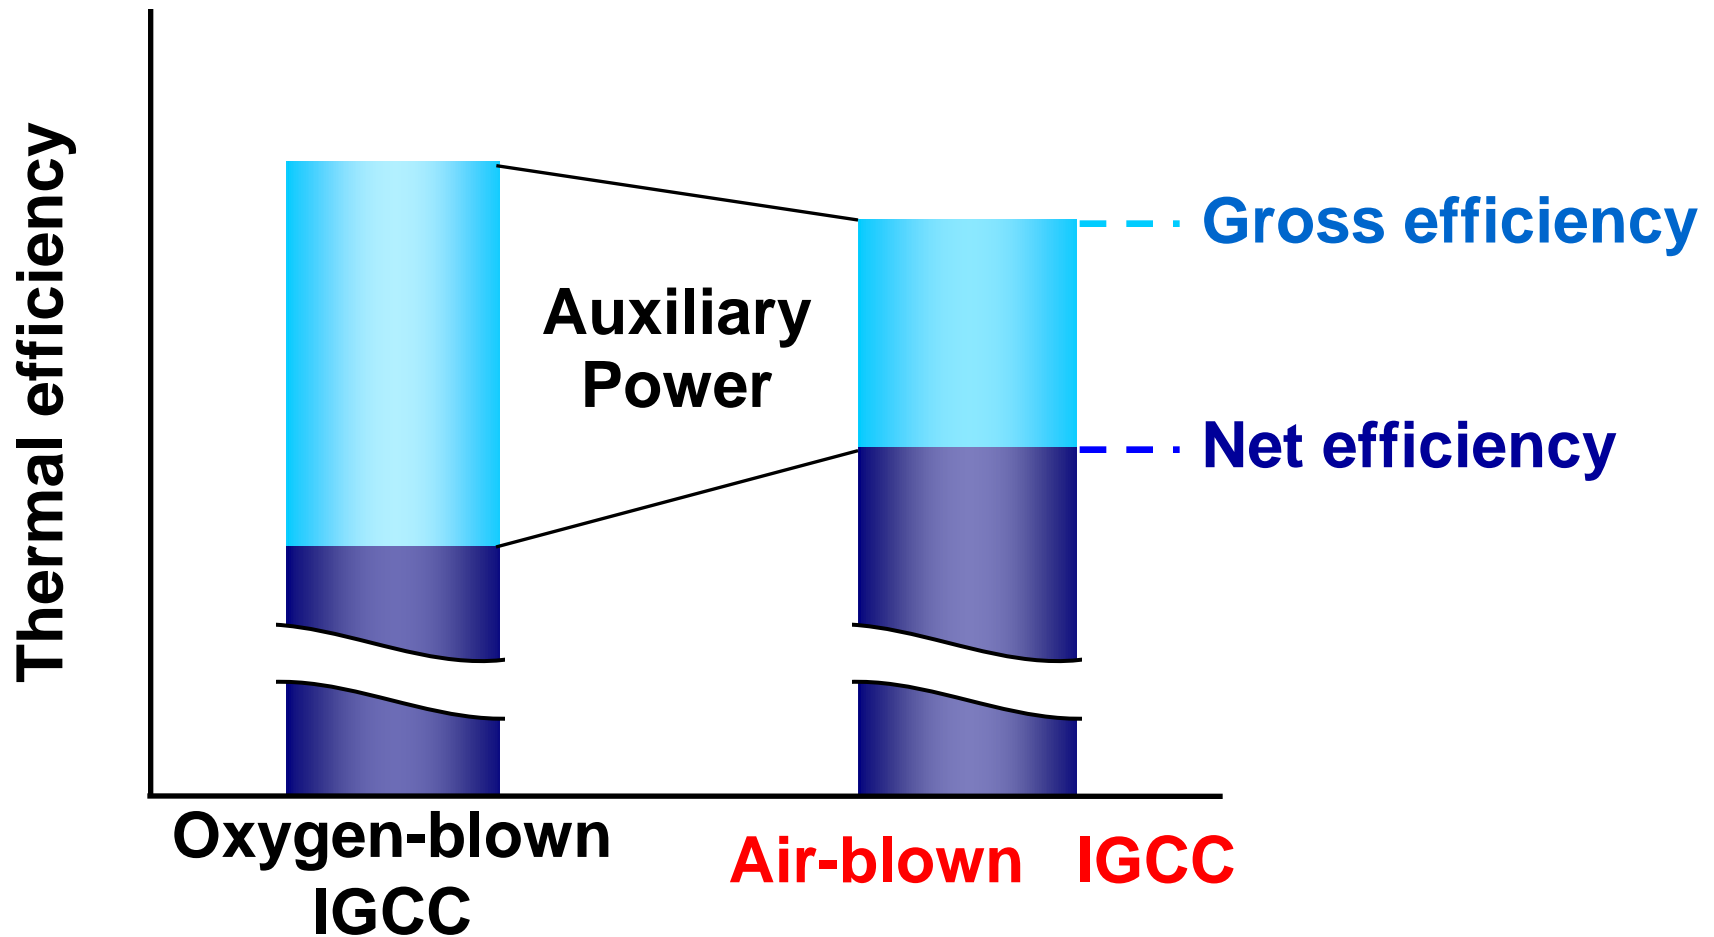
Advantage of Air-blown IGCC in Efficiency

Air-blown IGCC applied in Nakoso is expected to realize high thermal efficiency compared with oxygen-blown IGCC.

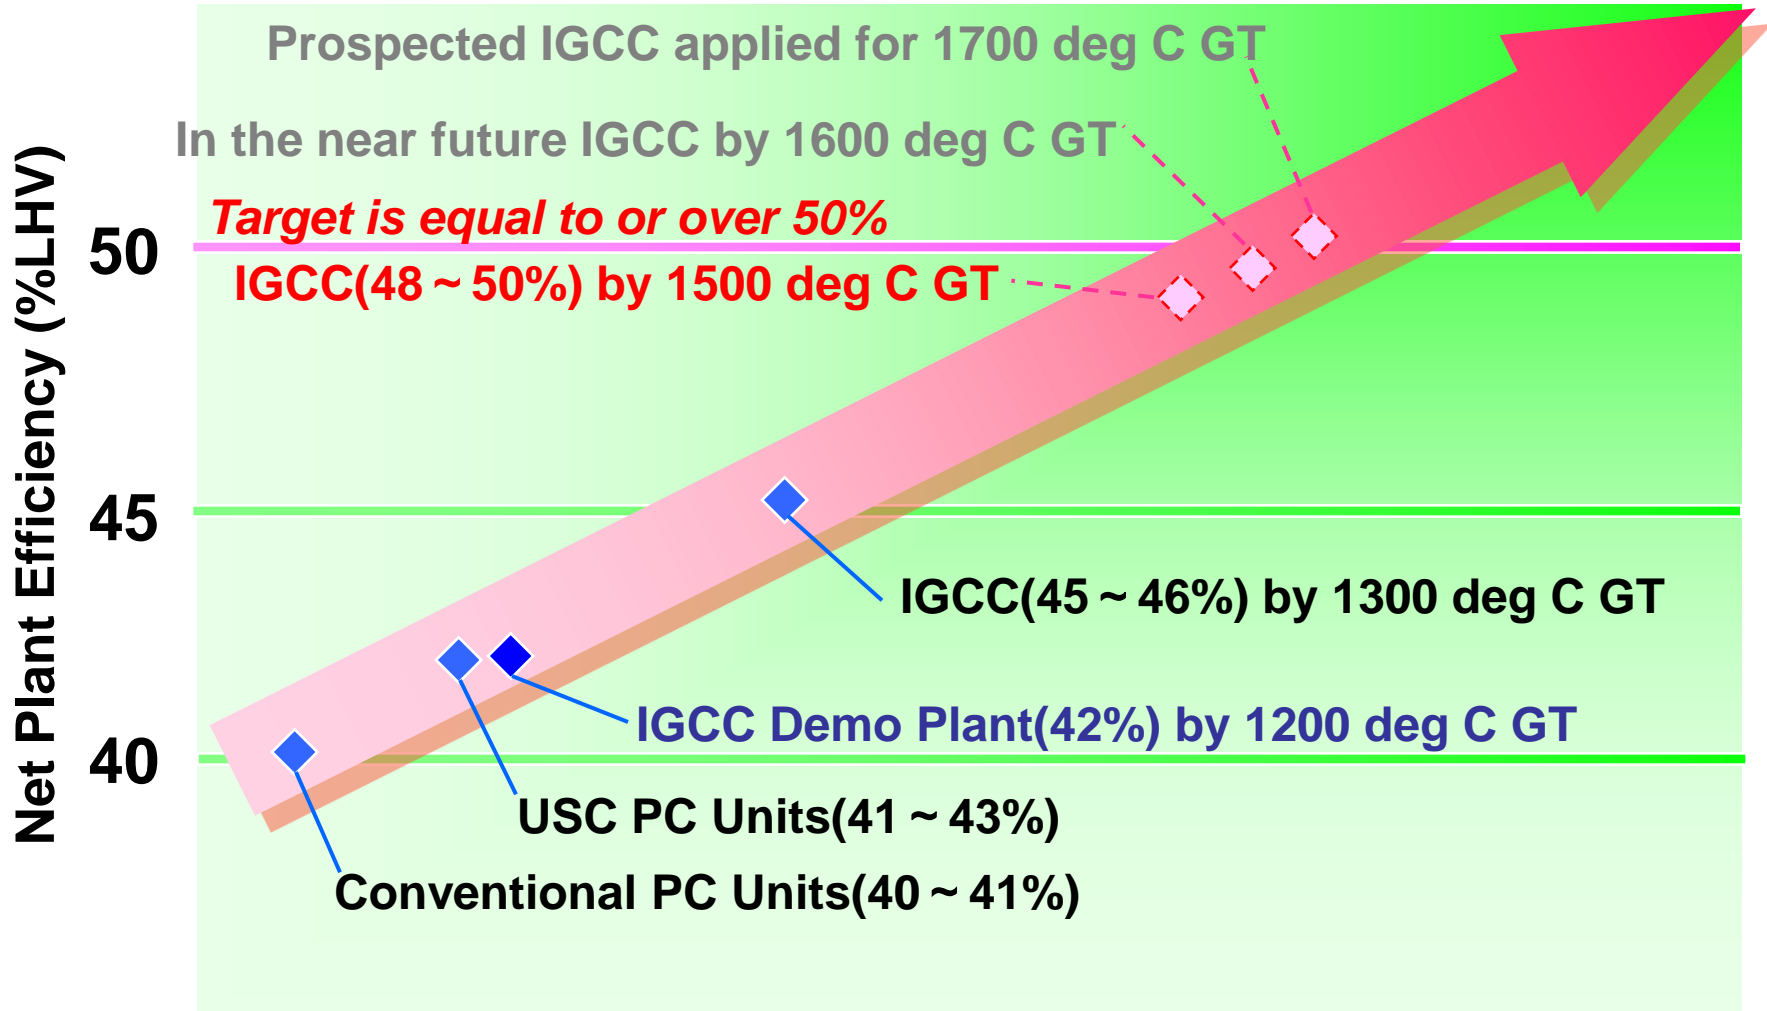
Thermal efficiency Improvement

Thermal efficiency improves in combination with high temperature gas turbine combined cycle technology.

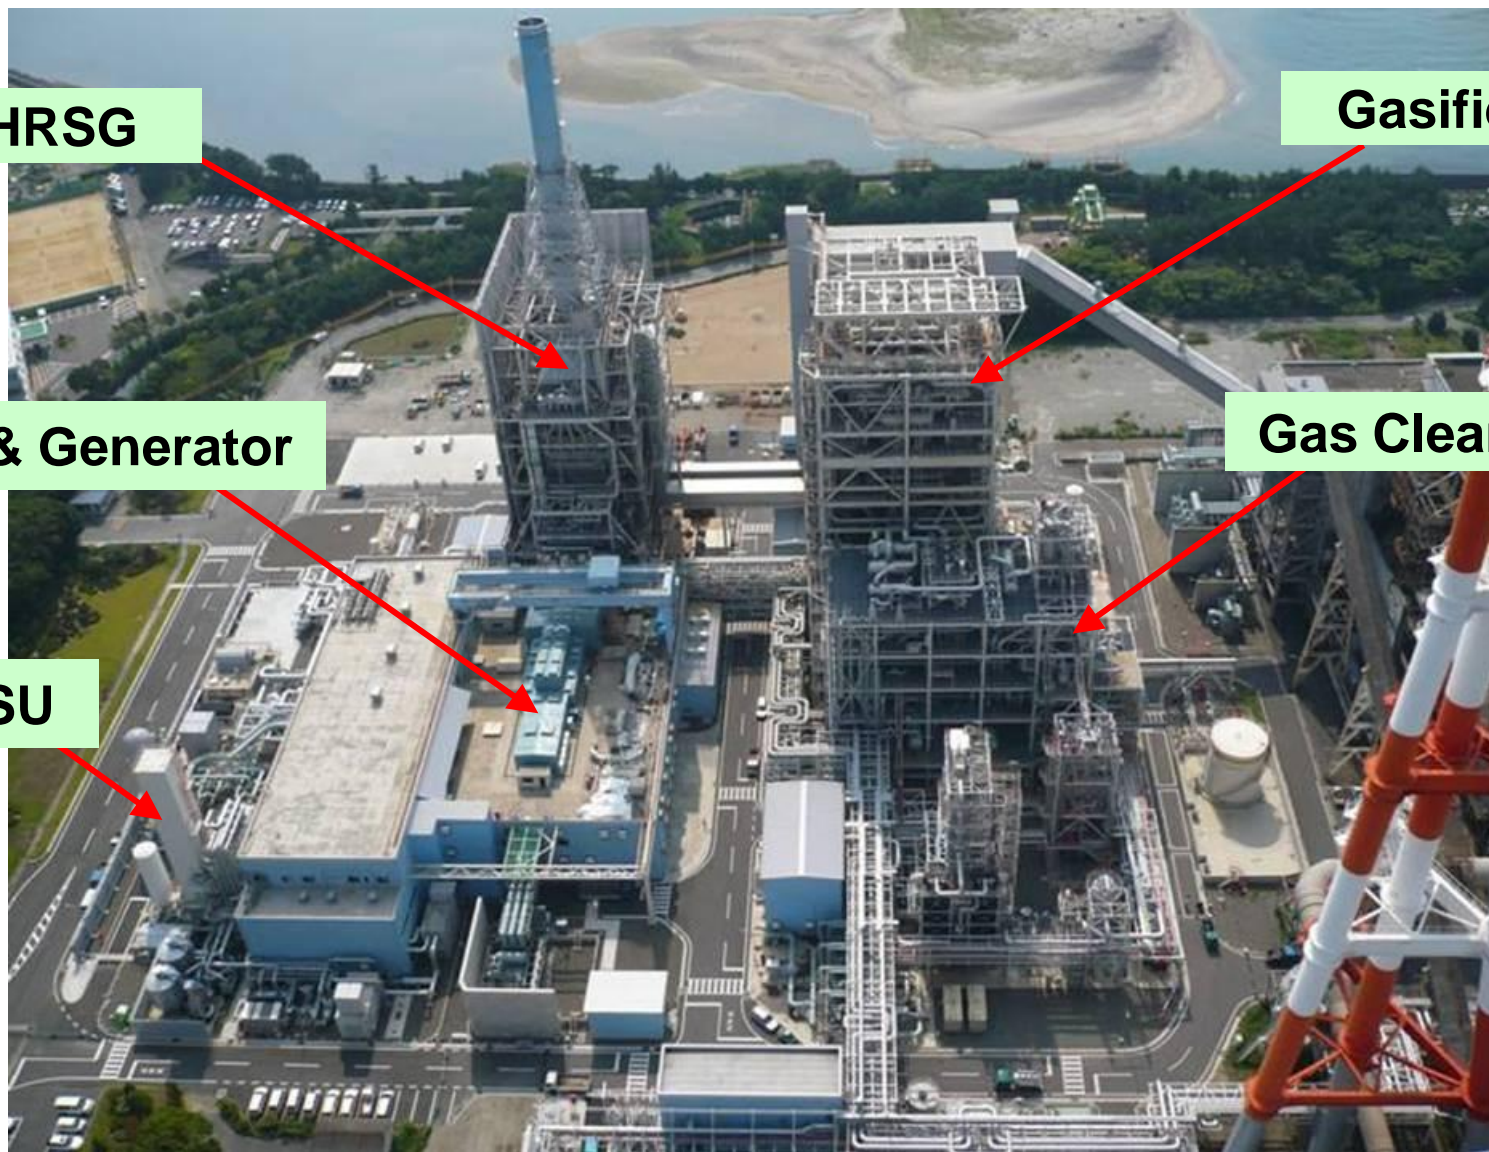
Bird's-eye view of IGCC Demonstration Plant

HRSG

Gasifier

GT, ST & Generator

Gas Clean-up

ASU

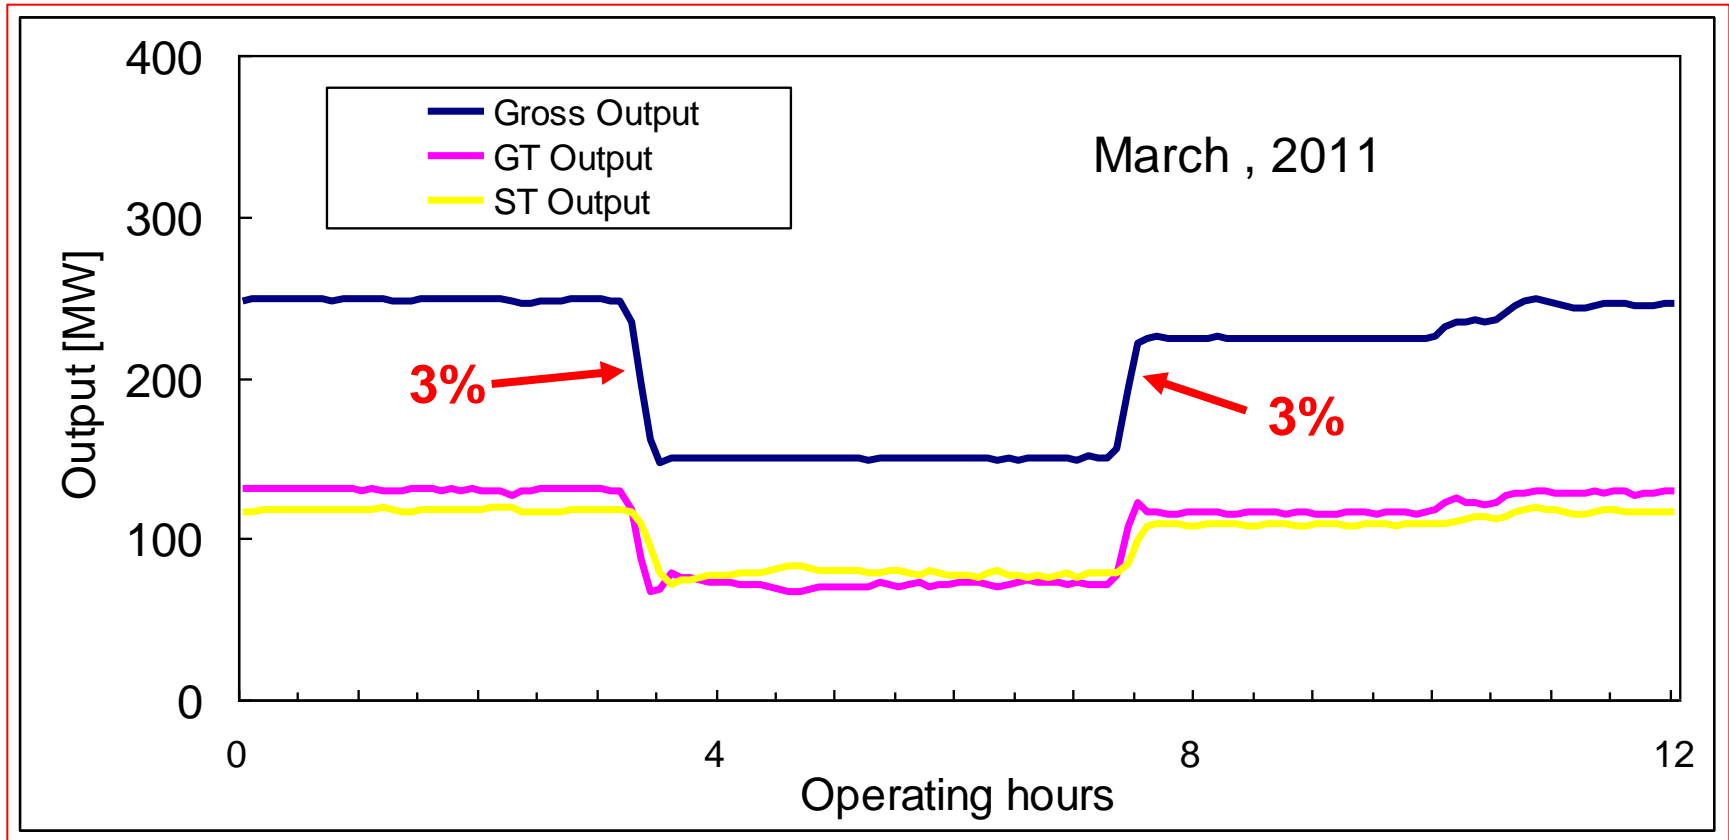
Load Change Rate

Load change rate of 3%/min which is compatible with conventional PCF in Japan, was realized by adjusting the operation parameters.

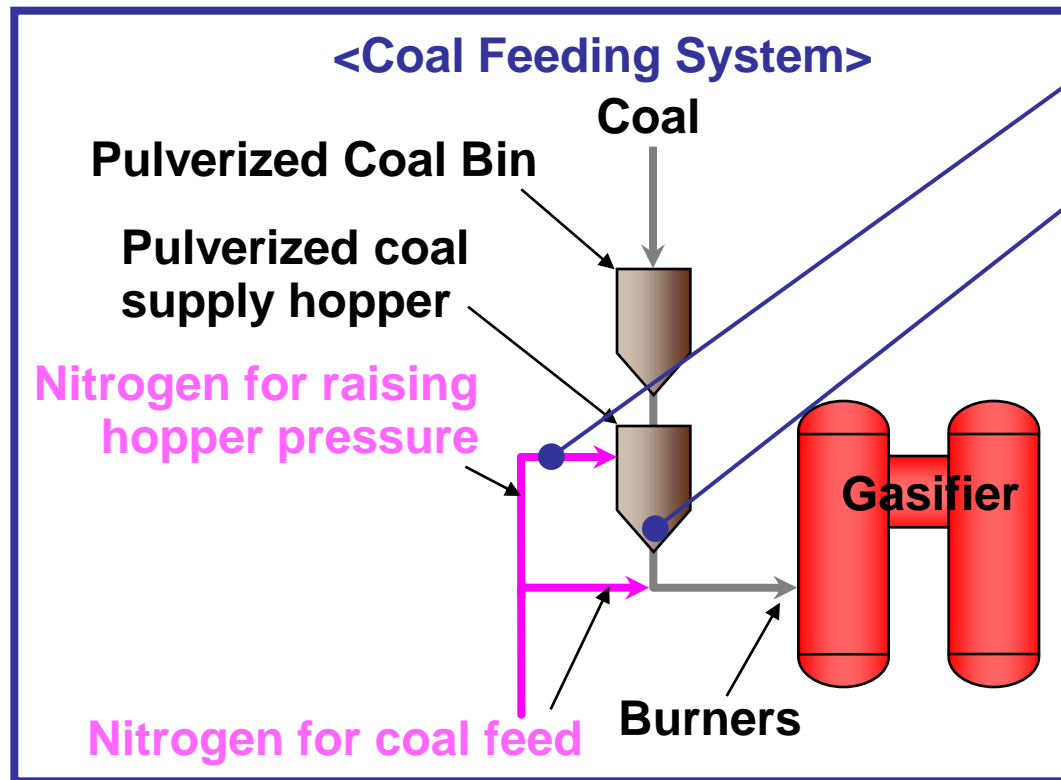
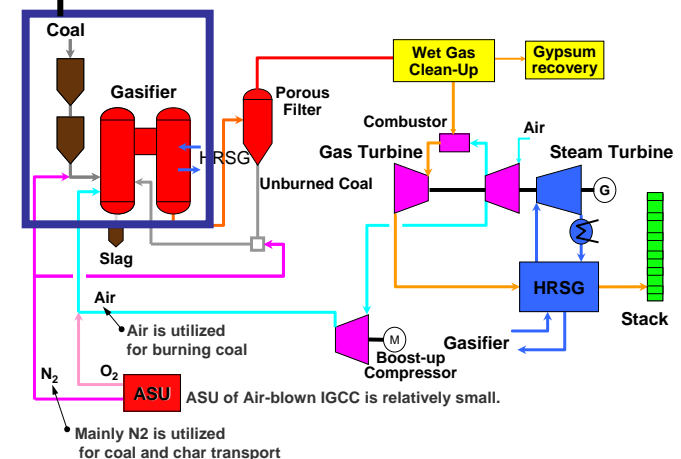
Improvement of dry coal feeding system

Unsteady coal feeding caused a difficulty on gasifier operation at trial operation in 2007.

The problem was solved by modification of coal feeding system and operation of IGCC system became stable.

Modification system

- >Improvement of pressurization control of the hopper
- >Improvement of fluidization in the bottom cones of the hopper

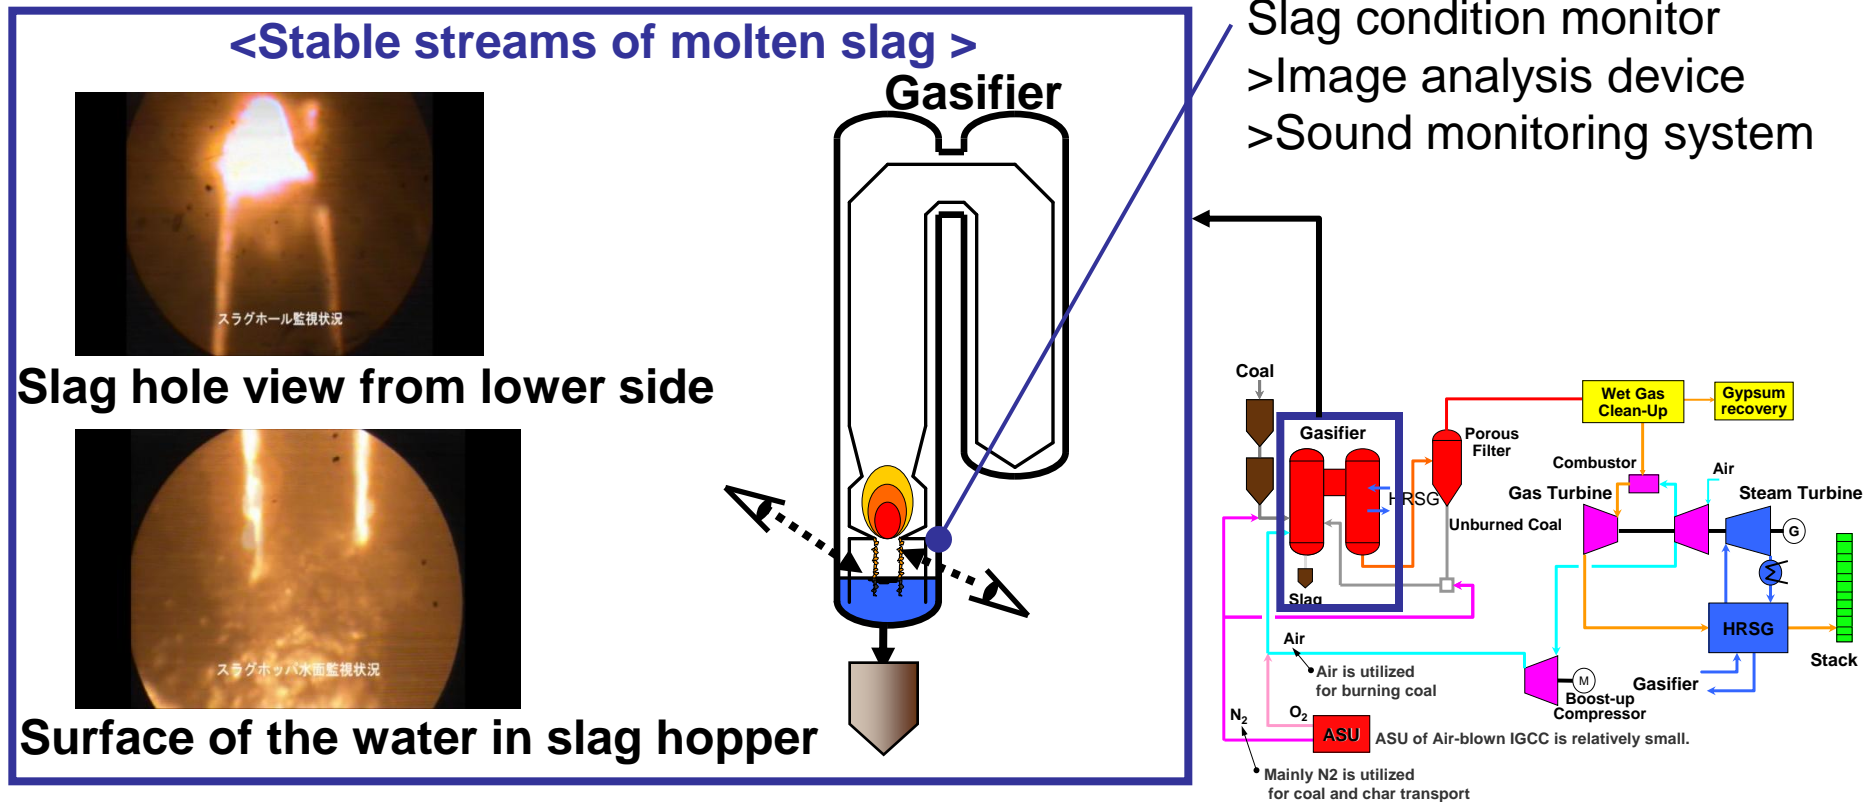
Development of the slag condition monitoring system

Slag hole blockage has never happened during operating test .
The flow of molten slag is constant, which means that the gasifier is operating in a very stable condition.

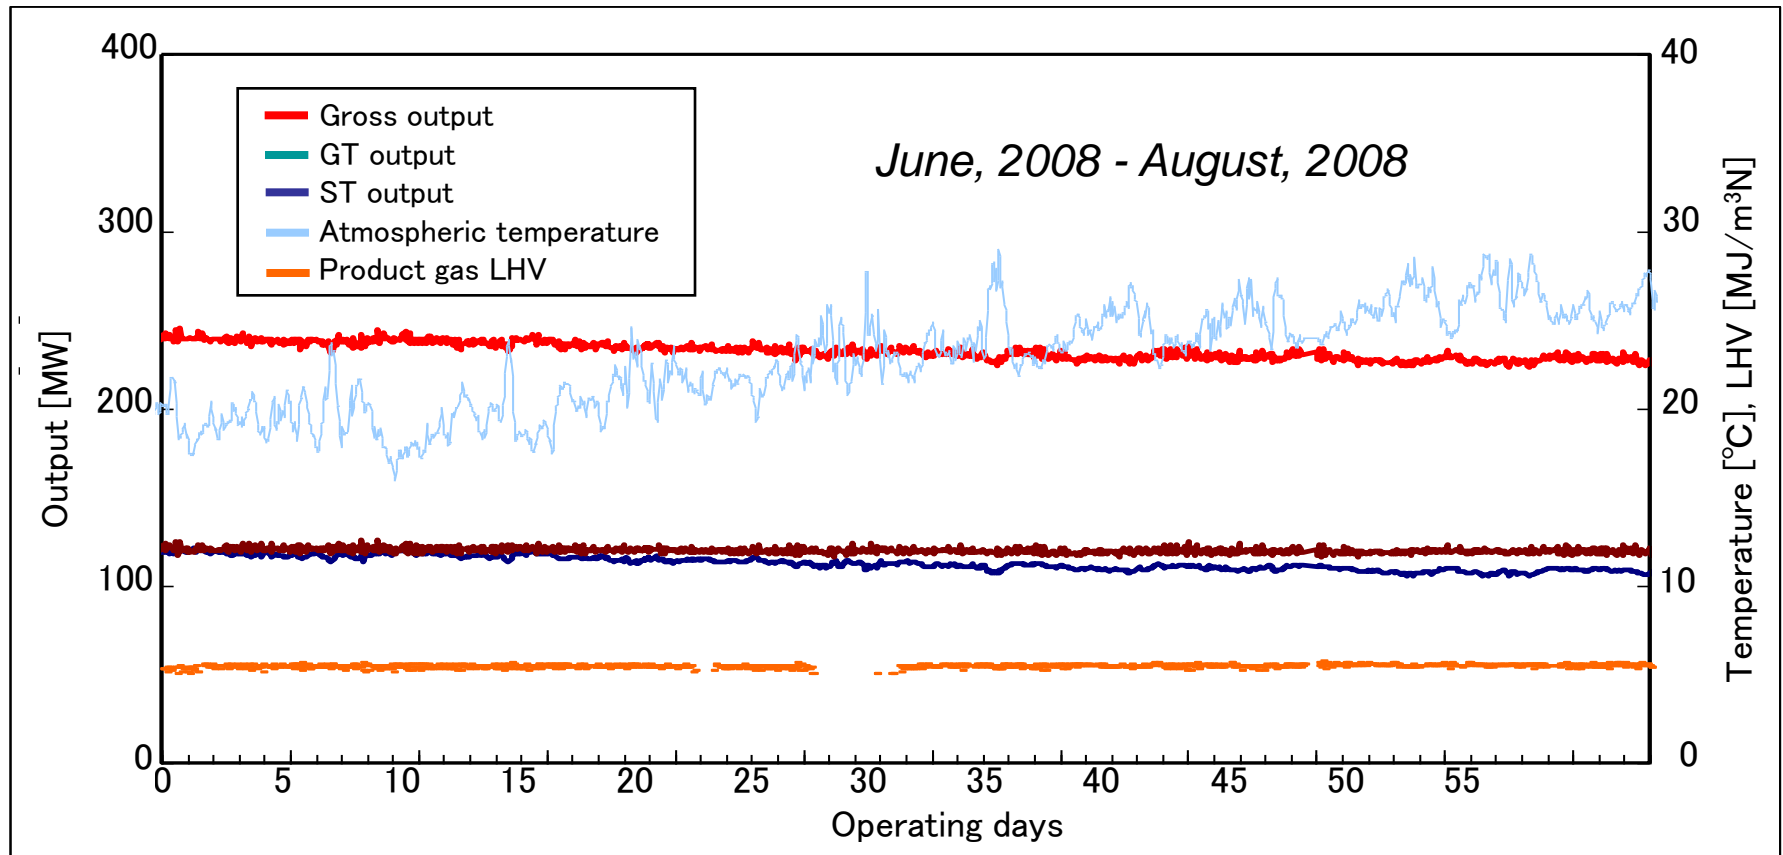
Trend data of long term reliability test conducted in 2008 summer

- Capability of stable power generation was confirmed.
- 2000 hours continuous operation was achieved in the first year.
 - > Total operating hours reached 2,039 hours.

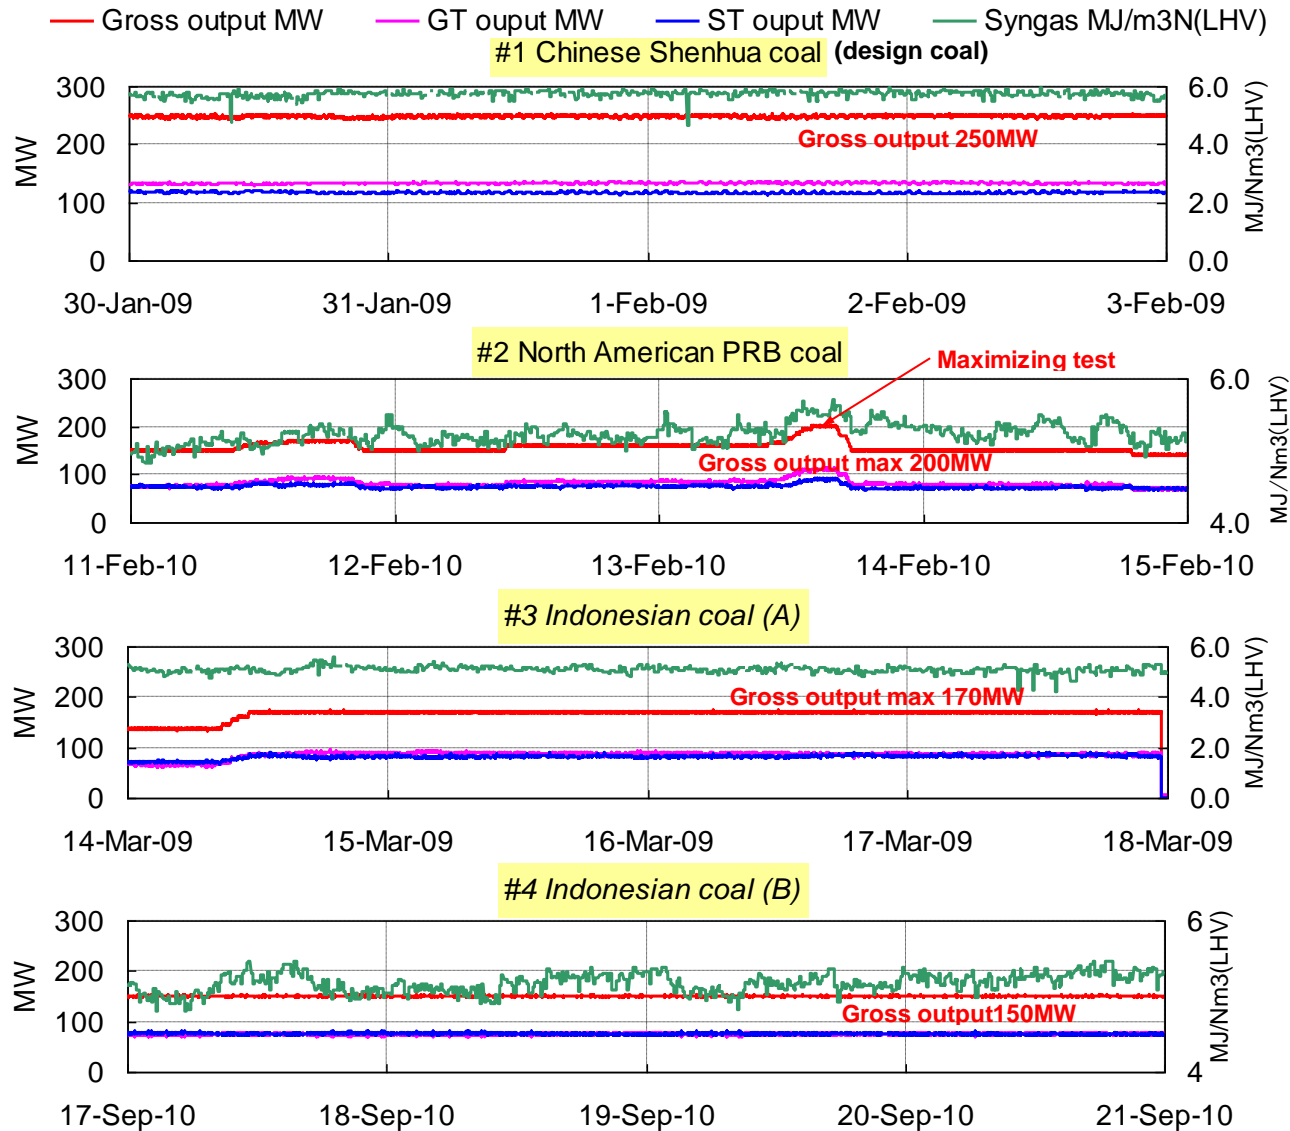
No.3:Fuel Flexibility (2) ; Test result (1)

Stable power generation using various coals was confirmed.

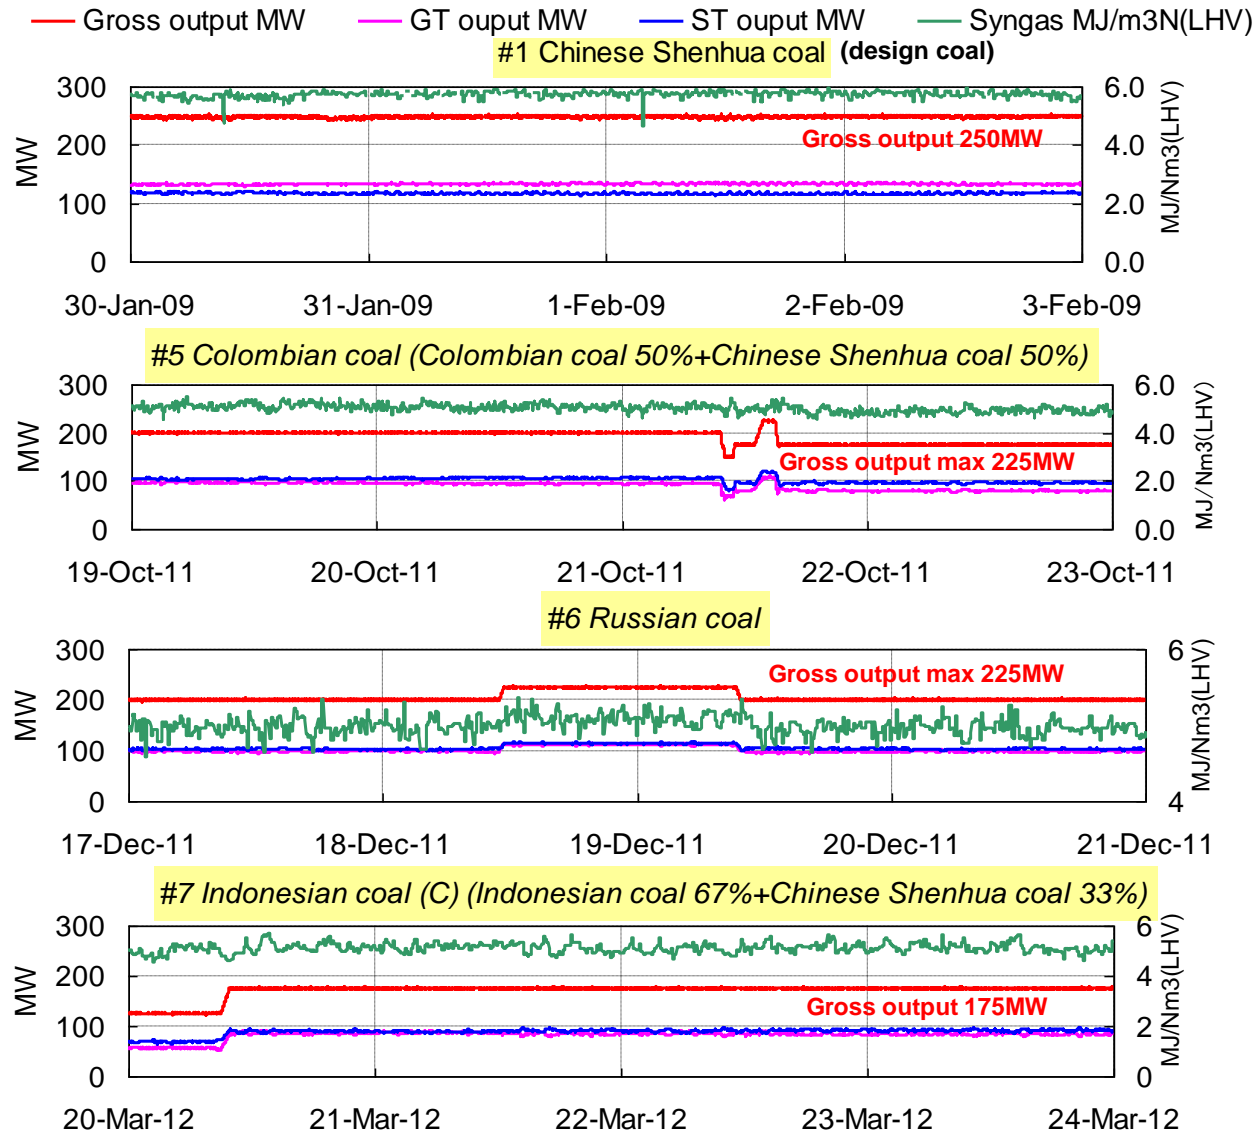
No.3:Fuel Flexibility (2) ; Test result (2)

Stable power generation using various coals was confirmed.

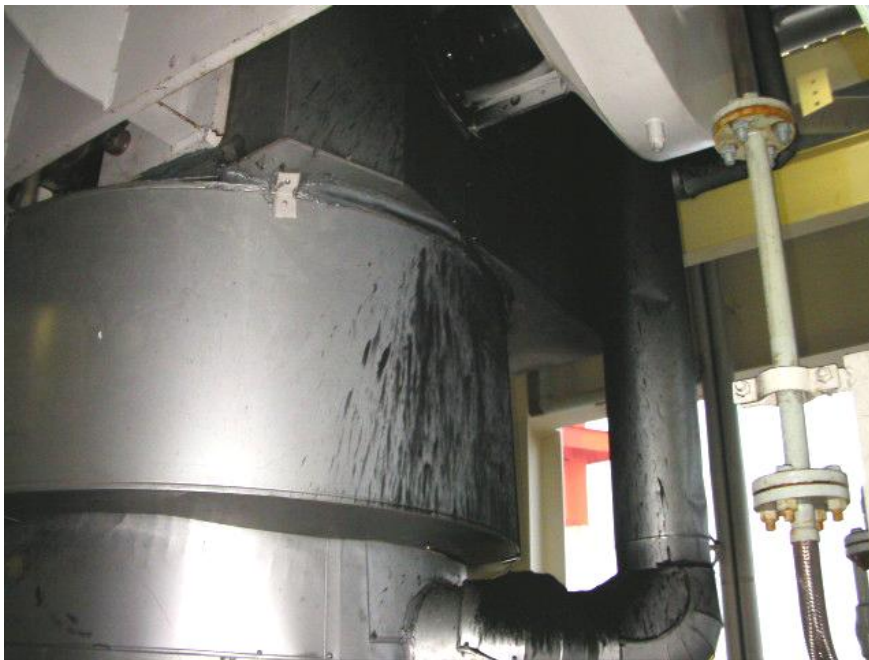
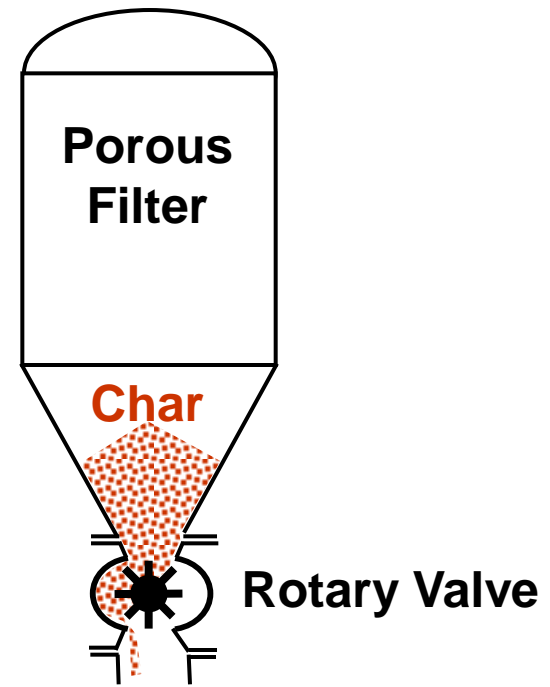
Char leakage from rotary valve under the porous filter

Tightening shortage of gasket

Proper tightening of gasket

Item of Incident	System	Root Cause	Cure
1.Leakage from Gland packing of Rotary Valve below Porous Filter	Char Recycle System	Inadequate tightening of a packing caused the gas leakage from the ground.	Proper control of tightening the packing at the ground

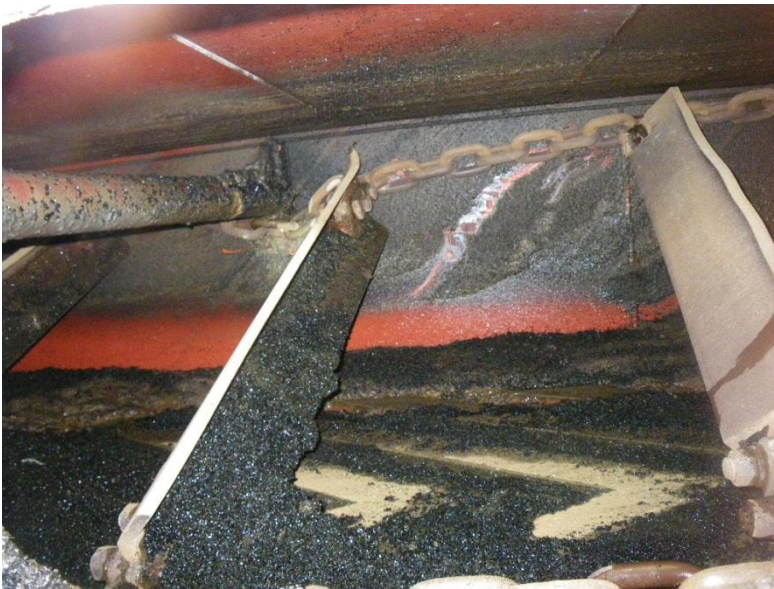
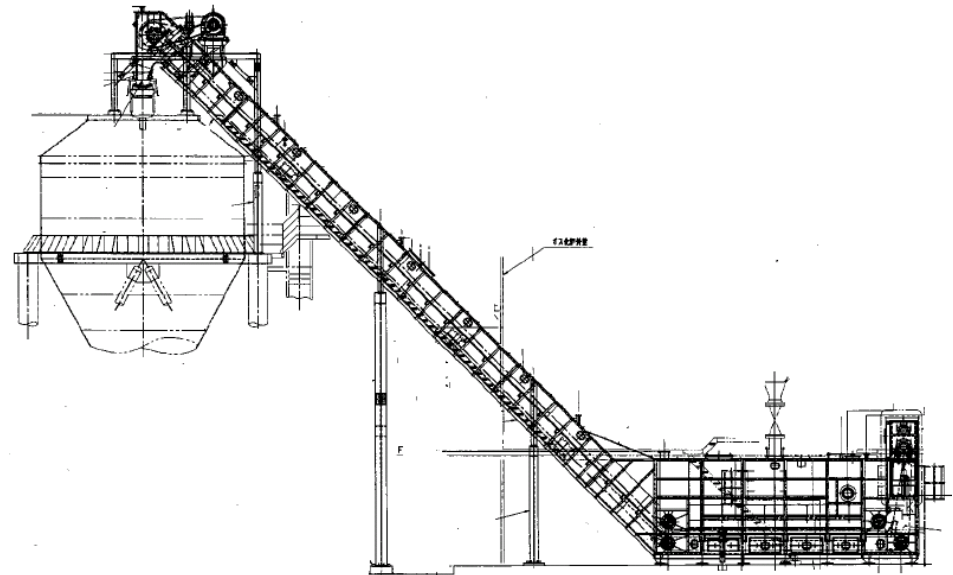
Breakdown of slag conveyer

Slag conveyer meandered, and parts were damaged.

The structure of the bottom plate of the conveyer was changed.

2.Trip of Slag Discharge Conveyor	Slag Treatment System	Scraper of the drag chain conveyor meandered and stuck onto the gutter of the bottom plate, and caused overloading of the conveyor motor.	Improvement of the conveyor structure

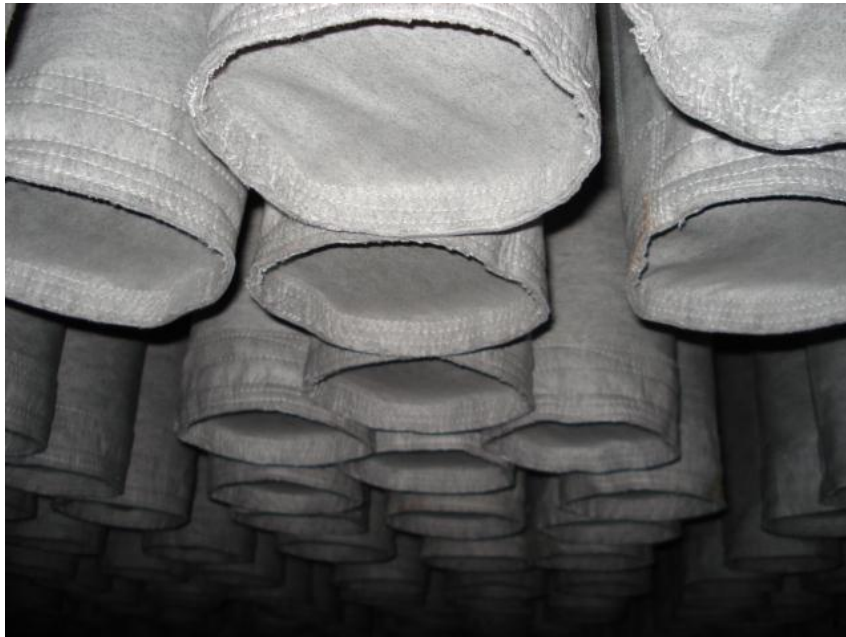
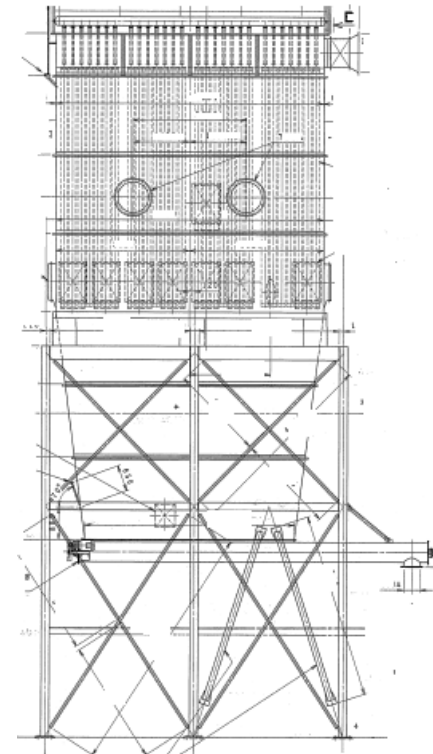
Pulverized coal leakage from bag filter

The bag filter was damaged.
Leakage was occurred by the breakage of bag filter.

The pulverized coal leakage monitor was set up.

3.Leakage of Coal from the Pulverized Coal Collector	Pulverized Coal Supply System	Filter cloth tore and pulverized coal accumulated in the bag filter was oxidized and increased in temperature.	Monitoring device added and operation procedure improved

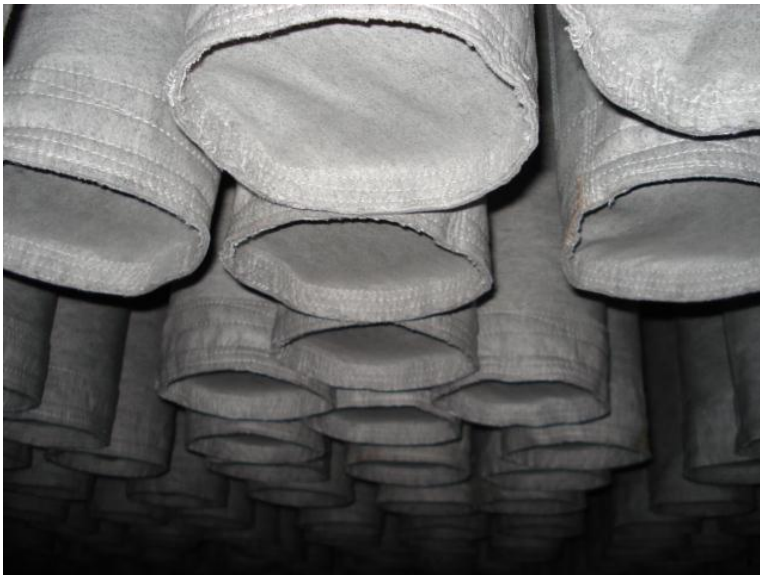
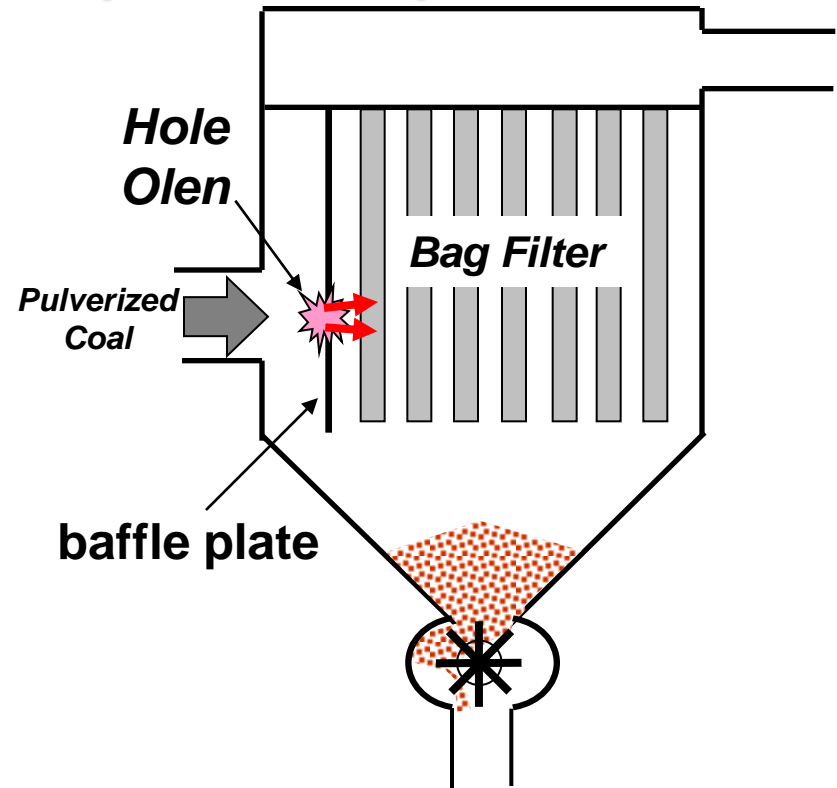
Pulverized coal leakage from bag filter

The bag filter was damaged.
Leakage was occurred by the breakage of bag filter. The hole open in the baffle plate in the pulverized coal entrance part.

The range of target plate in pulverized coal entrance baffle plate was expanded .

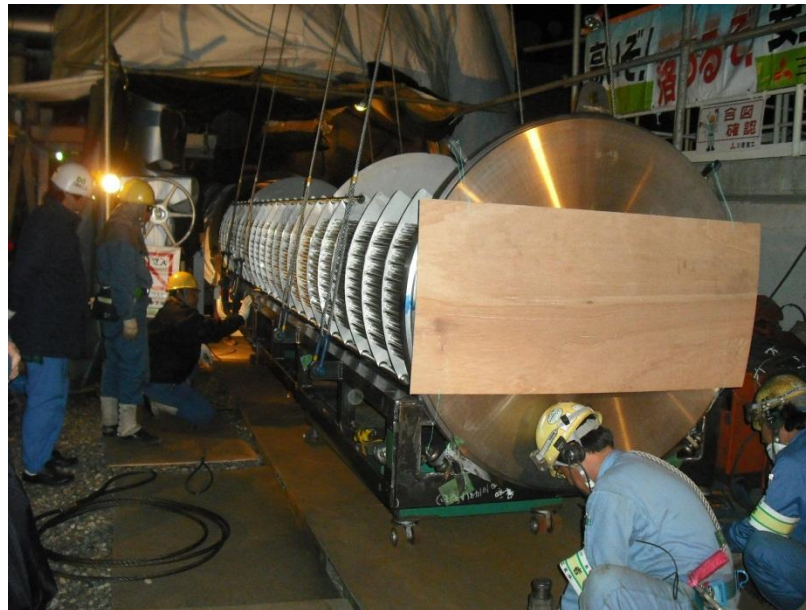
No2 Bleed Air Cooler Tube Leakage

**No2 Bleed Air Cooler Tube was damaged.
Leakage was occurred by the Stress corrosion cracking.**

The tube material was changed to titanium.

4.Leakage of No.2 Extraction Air Cooler Tube	Gasifier Air Supply System	Inadequate and irregular tube material selection caused corrosion. Air leaked to the condenser and resolved oxygen concentration in condensate water increased.	Tube material correctly changed

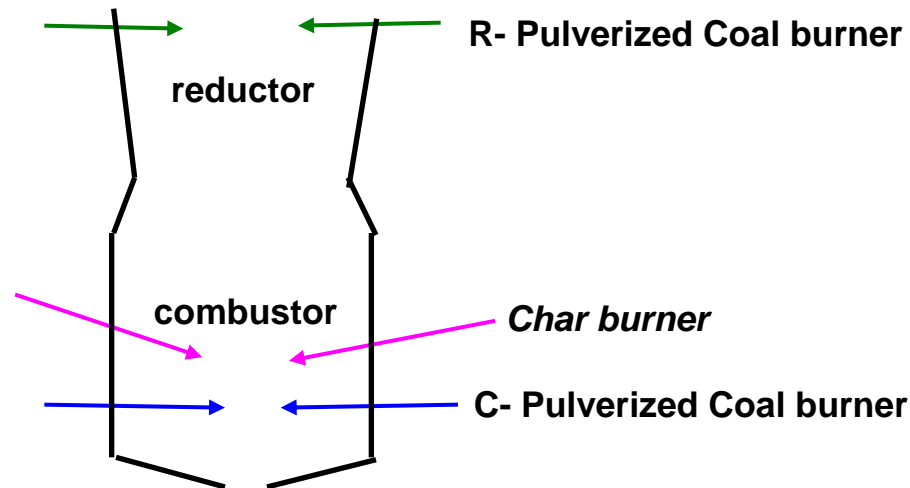
Leakage of Char Gasifier Burner Cooling Tube

The char accompanied by the secondary air eroded the burner cooling water tube.

The disposition of the burner was adjusted.

5.Leakage of Char Gasifier Burner Cooling Tube	Gasifier	Inadequate positioning of the burner front edge caused erosion of the burner cooling tube	Proper control of positioning the burner front edge

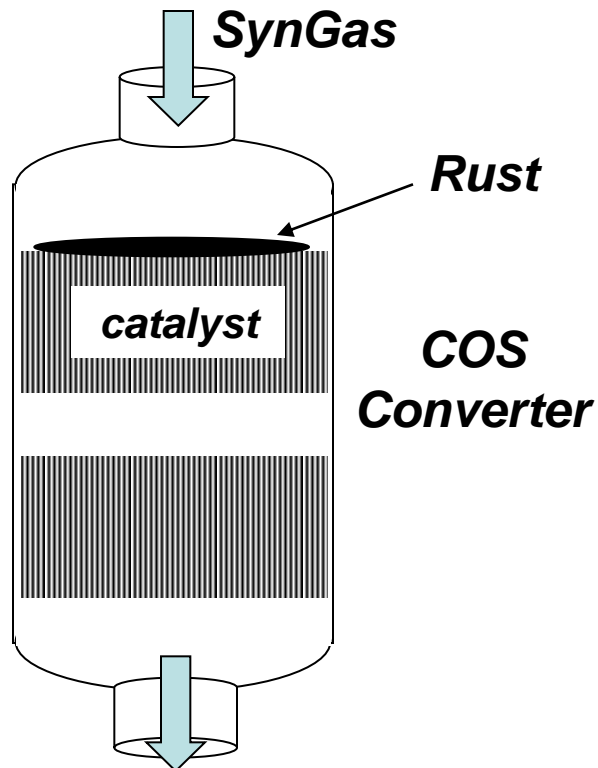
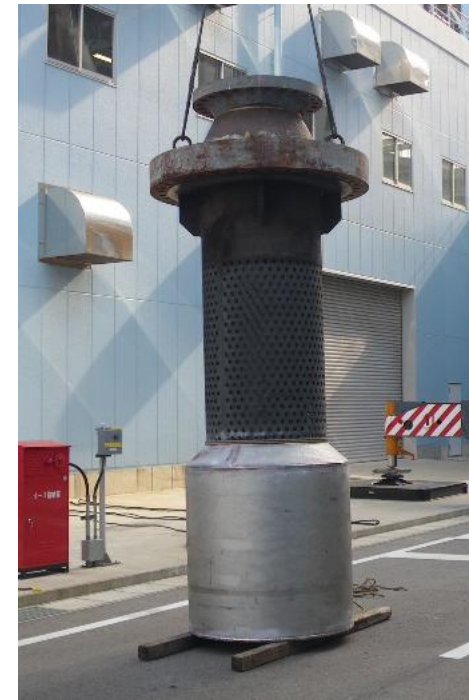
COS Converter Pressure Drop Increase

The piping rust piled up in the upper part of the COS converter catalyst.

The chamber that collected the piping rust was set up in the inside of the COS converter.

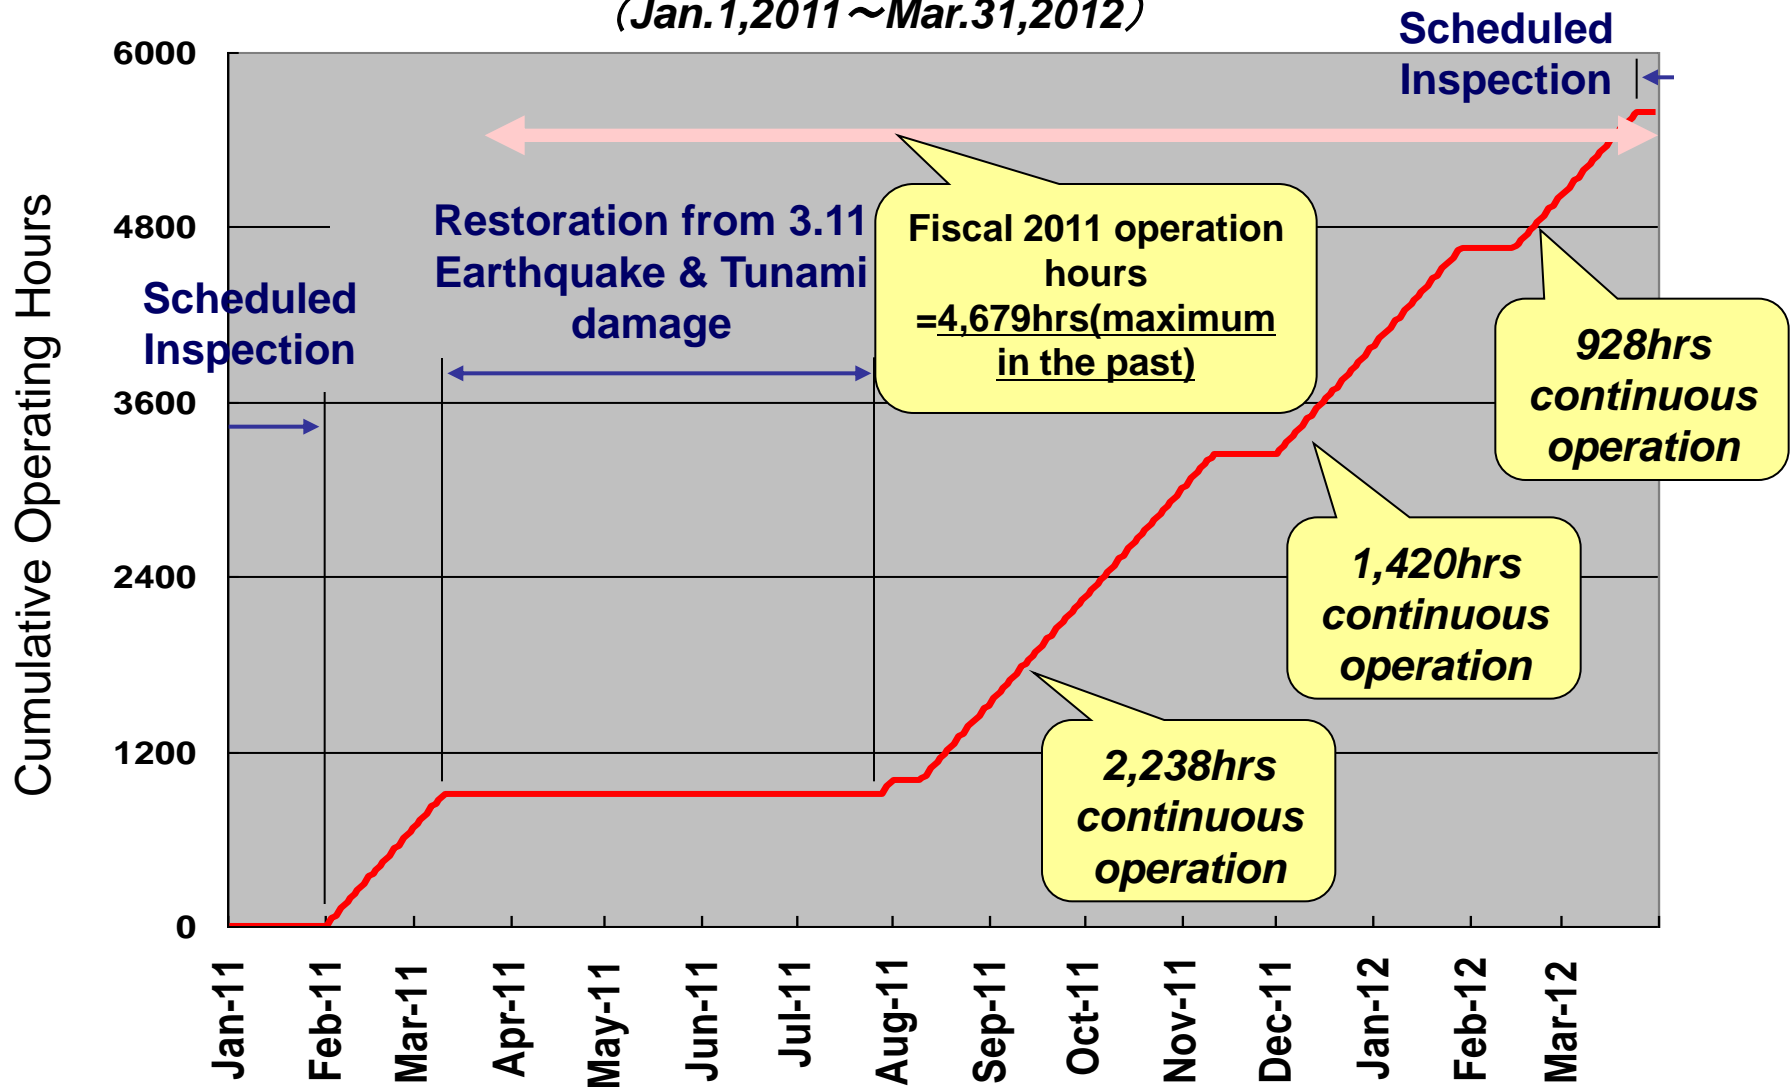
No.5:Durability (8): High availability after Tsunami

After the restoration from disaster, Nakoso IGCC is keeping high availability.
