Progress in Japanese Air-blown IGCC Demonstration Project Update

Clean Coal Power R&D Co., Ltd.

Located within the NAKOSO Power Station
of JOBAN JOINT POWER CO.,LTD.

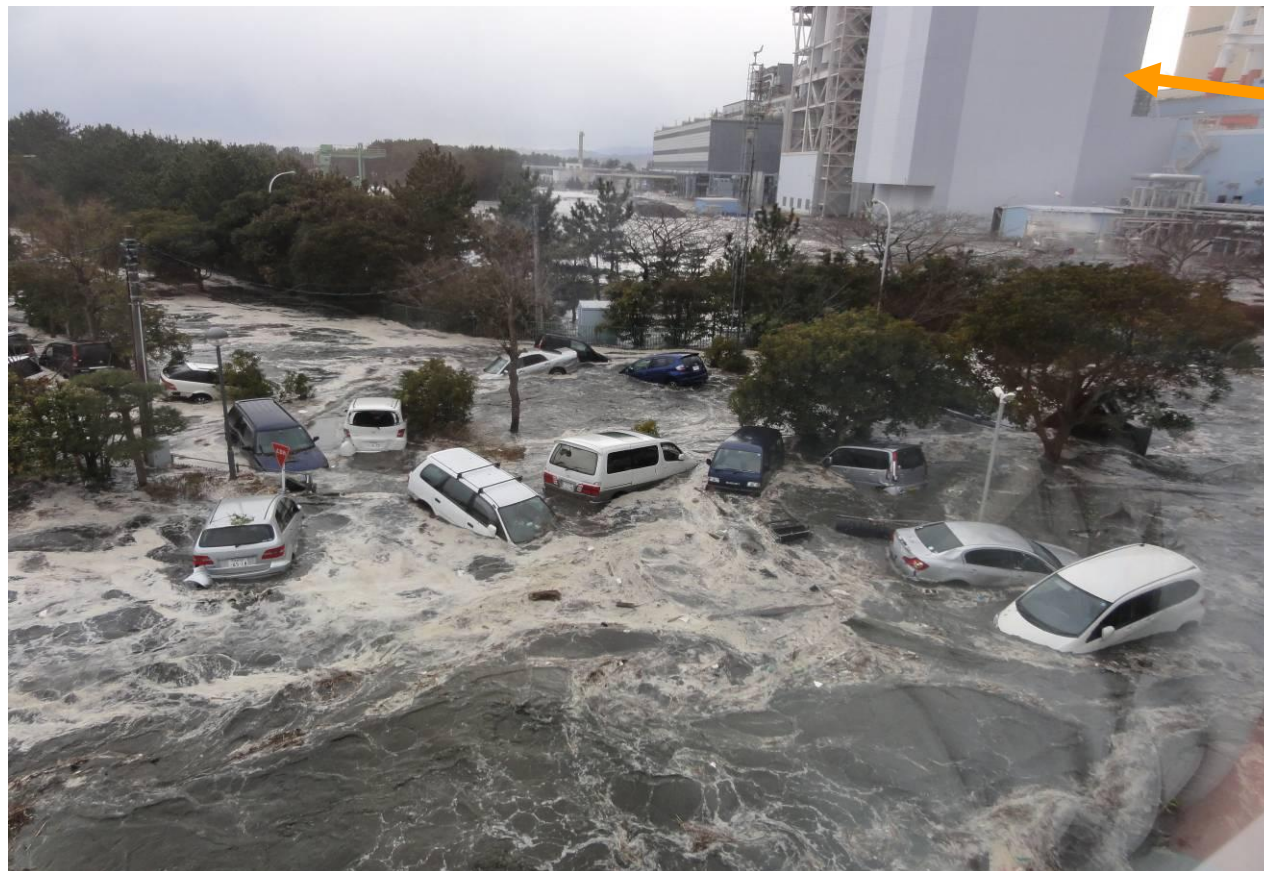
Nakoso IGCC incurred severe damages mainly because of the tsunami on March 11, 2011.

(strong jolts did not bring about fatal damages to the facilities)

- *March 11th, 2011* IGCC System halted its operation safely
A lot of facilities were submerged
No fatal damage in the main IGCC system
- *In March* Minimum personnel stationed while preparing for the worst case of the nuclear accident
- *Early April* Starting the restoration work
(on April 11th and 12th, additional strong jolts)
- *Between mid April and end of June*
Restoration work continued
- *July* Test and adjusting and *started the operation on 28th*
- *After August 10th*, Continuous operation for 2238 hours
- *Fiscal 2011* , Total operation hours = 4,679hours
